Temperature affects on battery charging

Product type: NXRT UPS internal battery and battery pack modules

Purpose: The purpose of this bulletin is to notify NXRT UPS system customers of an issue found in regard to a small number of NXRT systems exposed to local ambient temperatures >77°F for a periods of time.

NXRT Battery Inspection Procedure

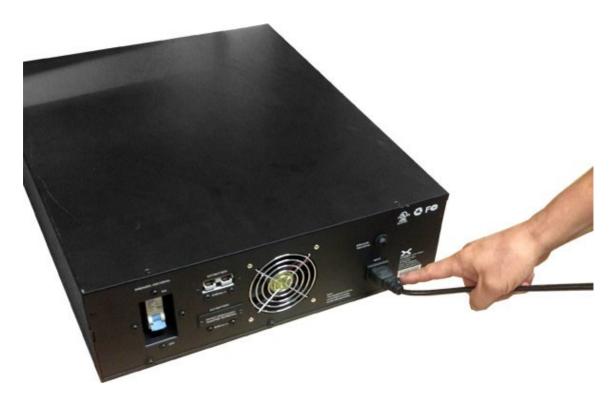
1. Remove all AC power cords connected to the EBP's. Contact Xtreme Power Technical support at 800-582-4524 for systems with over (4) NXRT-EBP's.

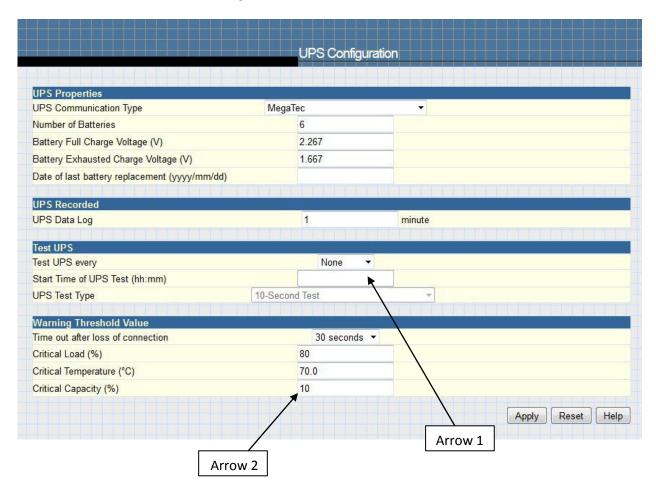
4. If SNMP Card is installed:

- A. Run battery test. See arrow 1.
- B. Modify critical capacity % alarm to better alert when batteries are low. The default is 10% and can be changed to 30%. See arrow 2.

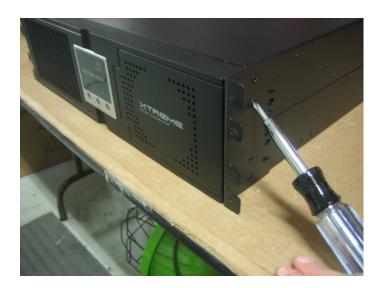
1. Make any needed steps to access the UPS's right front bracket. Remove (4) Phillips head screws to remove the UPS's right front bracket.

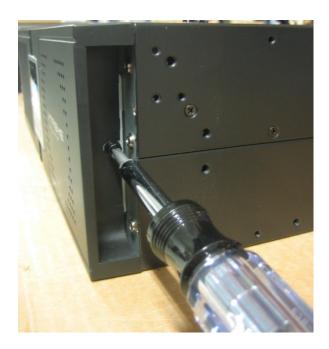
2. Remove the Bezel set screw

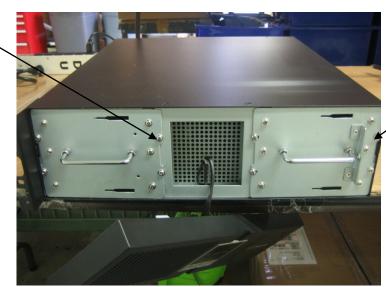
4. Remove the necessary <u>outer</u> sets of screws to slide out the desired battery tray. <u>Caution</u>- the battery tray is approximately 45lbs.

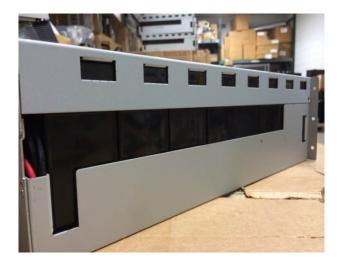
5. Visually inspect the battery tray. Check to see if the battery tray and/or batteries are deformed due to swollen temperature affected batteries.

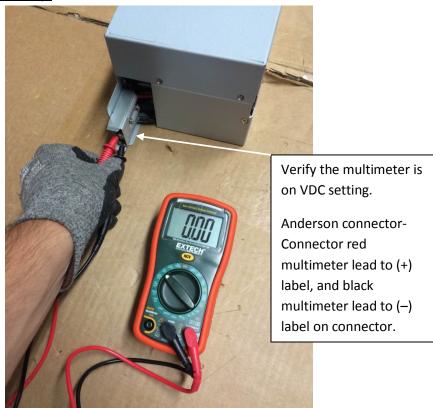
6. **If possible,** measure the voltage at the Anderson connector using a multi-meter at the back of the battery tray. Verify polarity and voltage. Acceptable voltage levels will vary depending on the model NXRT battery tray that is being inspected. *Reference the table on page 7 of this procedure for full charge voltage levels to compare against the meter reading. If a multimeter is not available, then perform visual inspection only.*

Model UPS	NXRT-1000	NXRT-1500	NXRT-2000	NXRT-3000
Model EBP	NXRT-EBP1	NXRT-EBP2	NXRT-EBP3	NXRT-EBP3
Nominal Voltage Level	36VDC	48VDC	96VDC	96VDC
Full Charge Voltage	>38VDC	>51VDC	>100VDC	>100VDC

If the batteries in the tray fail visual inspection or string values are below full charge values, contact

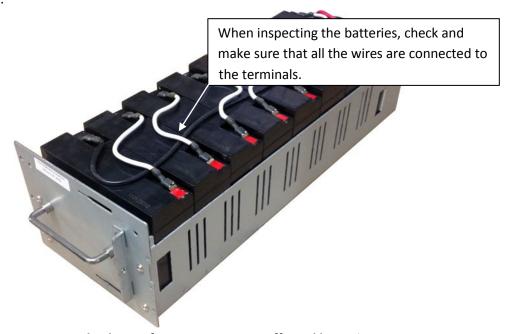
8. Visually inspect the batteries. Check to see if the batteries are swollen or if corrosion is present on the terminals.

Example above of non-temperature affected batteries

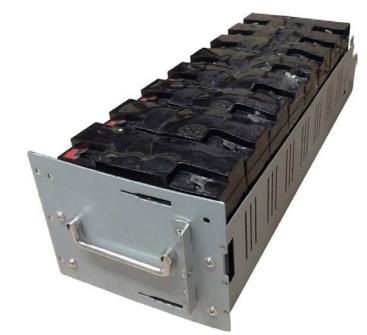
Example above of temperature affected batteries (shown without wires)

Temperature/Overharged affected battery Non affected battery

<u>If the batteries do not pass visual inspection, contact Xtreme Power Technical Support at 1-800-582-4524</u>

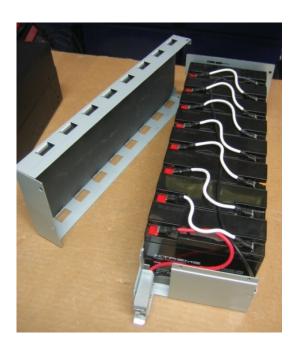
9. After visual inspection passes, replace top cover and secure the necessary screws

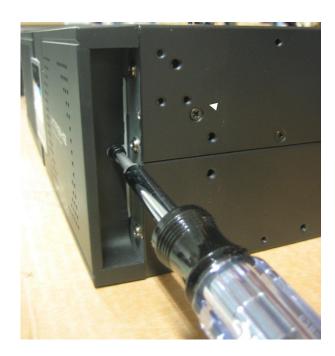
Secure front bezel screw

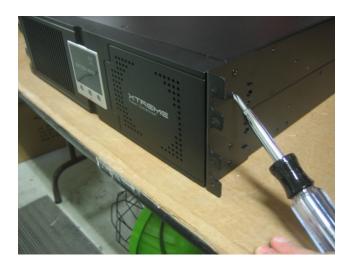
12. Replace right front bracket
